APOLLO 17 MISSION  
ANOMALY REPORT NO. 1

ERRONEOUS MEASUREMENTS TRANSMITTED BY TELEMETRY

APOLLO 17 MISSION  
Anomaly Report No. 1

PREPARED BY  
Mission Evaluation Team

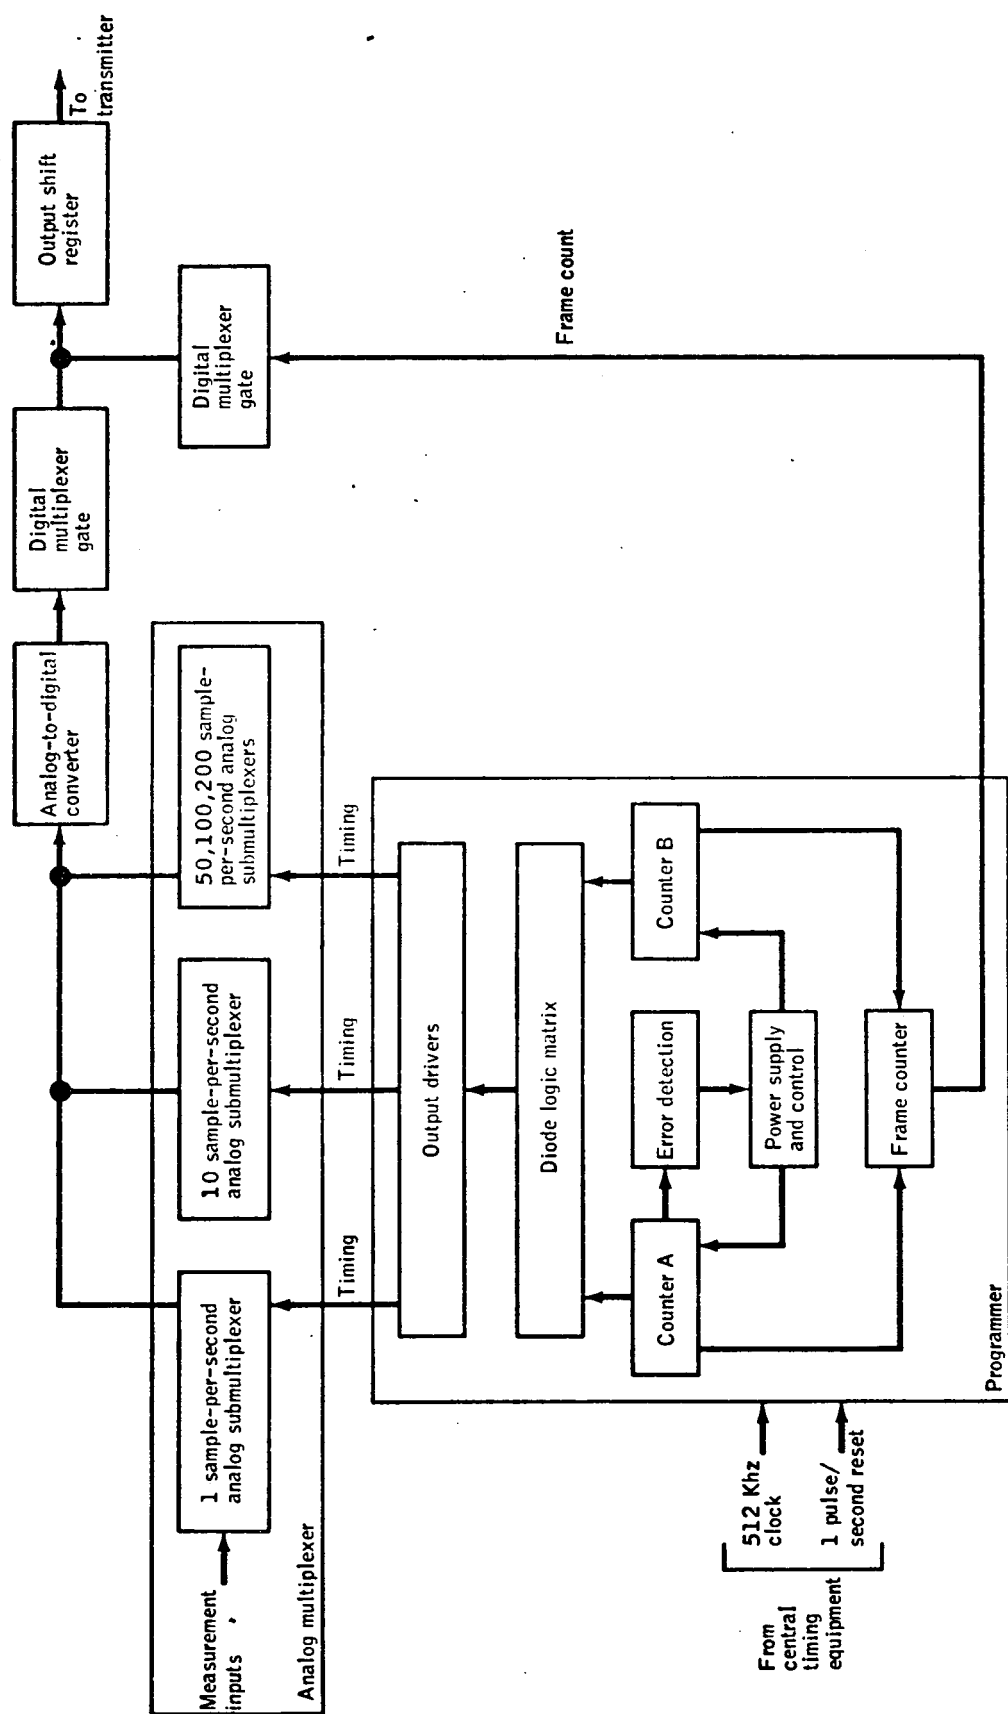
Figure 1. - Telemetry system analog measurement channels.

The telemetry system is of the pulse-code-modulation type and includes a programmer, an analog multiplexer, an analog-to-digital converter, a digital multiplexer, an output shift register, and associated power supplies (fig. 1).

Both programmer counters (fig. 1) may provide identical pulse-train inputs to the diode logic. However, only one programmer is powered at any given time, and the de-energized programmer counter does not affect the logic.

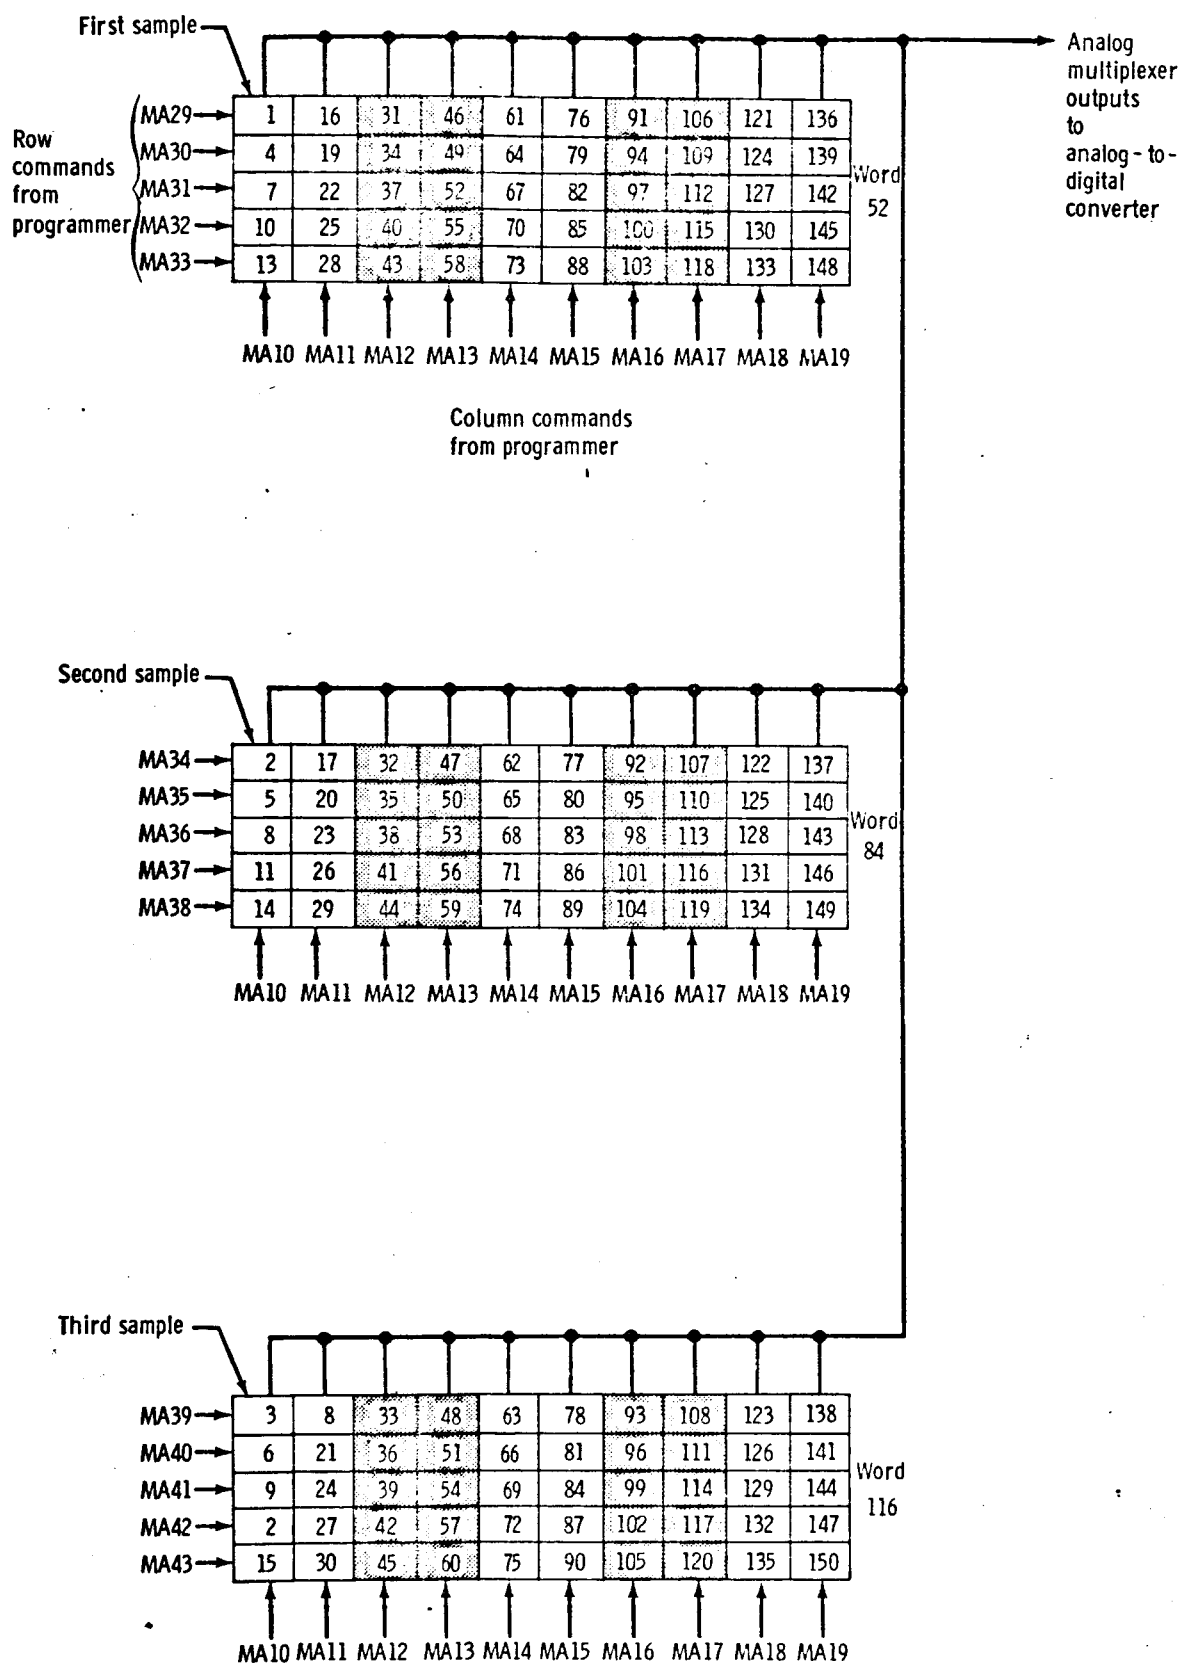
Figure 2. - Logic scheme of the one sample/second analog sub-multiplexer.

The multiplexer is made up of five sub-multiplexers, each of which samples its assigned channels at a different rate. These sample rates are 1, 10, 50, 100, and 200 samples per second. Each sub-multiplexer is arranged as a logic matrix (fig. 2), wherein each measurement input is sequentially sampled by the simultaneous application of a row and a column command to the matrix. Each measurement input sample supplies a voltage pulse having an amplitude proportional to the measurement value, and this pulse is transmitted to the analog-to-digital converter. The pulse amplitude is encoded into a digital word which is transmitted to the digital multiplexer for interleaving into the data-bit stream by the output shift register.

The telemetry system operates on a one-second duty cycle, with each duty cycle composed of 50 prime frames, each of which contain 128 words. Words 52, 84, and 116 of each 128-word prime frame are assigned as 1 sample-per-second data locations. Therefore, in 50 prime frames (one duty cycle) there are 150 one-sample-per-second data locations, and these are interleaved into the data bit stream. The order of sequencing the 1 sample-per-second inputs is shown in figure 2.

The erroneous readings occurred during all 1-sample-per-second sub-multiplexer row commands and during only 4 of the 10 column commands. Since the row commands are also used in the 10-sample-per-second sub-multiplexer where operation was proper, the row commands must have been proper. The column commands, however, are used only in the 1-sample-per-second sub-multiplexer, consequently, the problem must have been caused by improper column commands.
